VOELCKER PARK

HISTORIC STRUCTURES REPORT

October 28, 2008

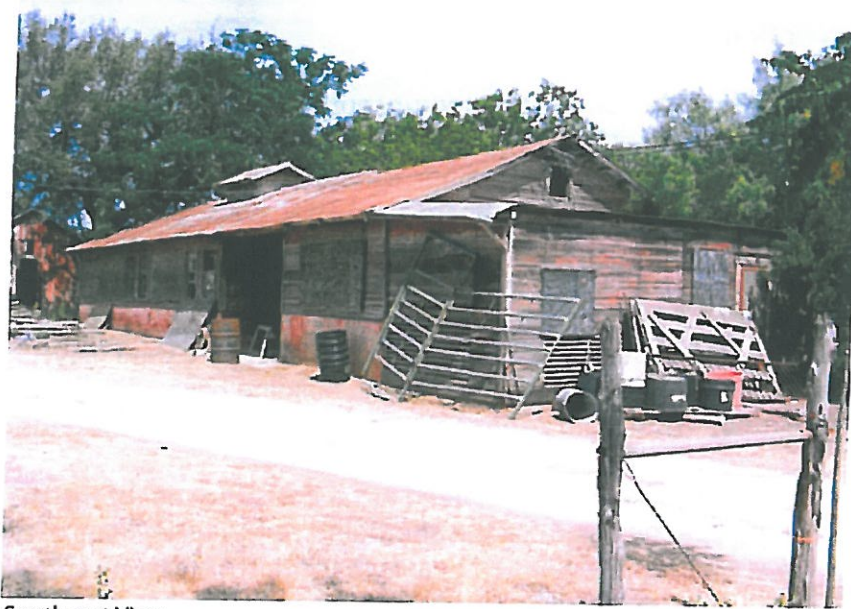
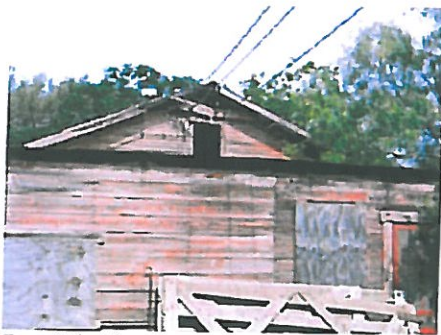
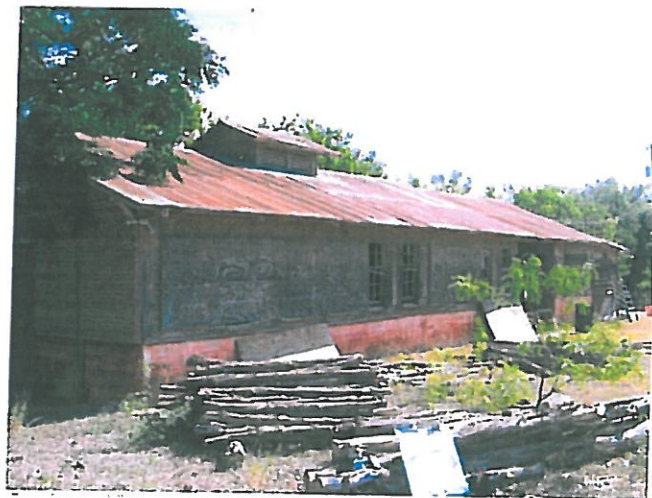
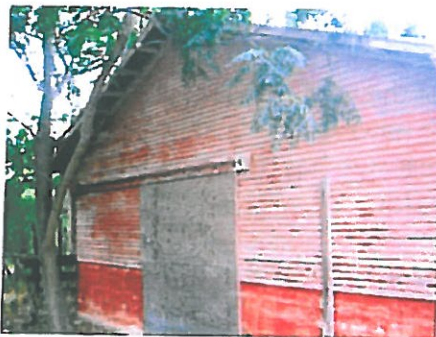
Assessment Rating: 5-Excellent 4-Good **3-Fair** 2-Deteriorated 1-Crisis

Foundation: The concrete slab-on-grade foundation seems to be in stable condition.

Walls: From the ground to 1/3 of the building's height, there is a concrete wall and from there up the north, south and west walls are framed with 2 x 6. The exterior of these three walls are finished with 2 ½" horizontal wood boards used as siding and painted a typical barn red. The walls of the shed do not have the concrete lower section and are sided with 5 ½" wide wood boards. The upper part of the east wall and the east and west walls of breezeway have also 2 ½" wood boards siding with the same paint finish.

Roof: The roof is a single gable running the length of the building. The roof is supported by wooden trusses supporting corrugated sheet metal roofing. The gable roof continues over the middle section of the barn that includes the breezeway and two rooms, but the trusses were discontinued in this addition in favor of roof joists. This section is also roofed with a single corrugated metal sheet, but is sagging at connection points to the original barn at the breezeway. This structural difference has allowed water to damage the roof framing. The roof over the shed at the east end is in poor condition, and the wooden structural members are deteriorated.

Windows: The windows are double-hung wood windows with a four-over-four sash pattern. The majority of the sash, frames, mullions, and glass are in bad condition and will have to be replaced, however there are some entire windows (as well as some window members) that can be salvaged. The inside of the frame measures 25 1/4" x 54 1/4", with trim boards of 5 1/2" x 3/4" finished in red barn paint.

Doors: The sliding door for wagons and stock at the west end of the milking barn lies on the ground and therefore will most probably require total reconstruction. The sliding door at the north side of the breezeway is still in place but has fallen from its railing. The other exterior doors to the breezeway are in repairable condition, however, some jambs are rotted and show signs of termite damage. All these exterior doors are finished with typical red barn paint.

Comments: The breezeway floor is lower than the finish level of the milking barn and the two rooms to the east and therefore will have to be made and accessible. The majority of the windows will have to be restored or replaced but some of them can be salvaged. The building has to be treated for termite damage before any preservation work is performed.

The dairy barn is a good candidate for rehabilitation that will allow an adaptive use of the building. This rehabilitation will require significant repairs to the roof, walls, floors, doors, and windows. The replacement of some members will be necessary.

1. Proper grading around the building is crucial for its preservation.
2. Termite treatment of all wooden members is required.
3. Determine which wooden members are rooted and replace them.
4. Repair and re-paint concrete walls.
5. Repair roof structure over breezeway and rooms to the east.
6. Repair doors and windows.
7. Reconstruct damaged walls. Treat for termites. Paint wood trusses structure.
8. Introduce an insulation layer under the roof and in the walls to allow the building to be occupied.
9. Re-paint all building elements when repairs are complete.

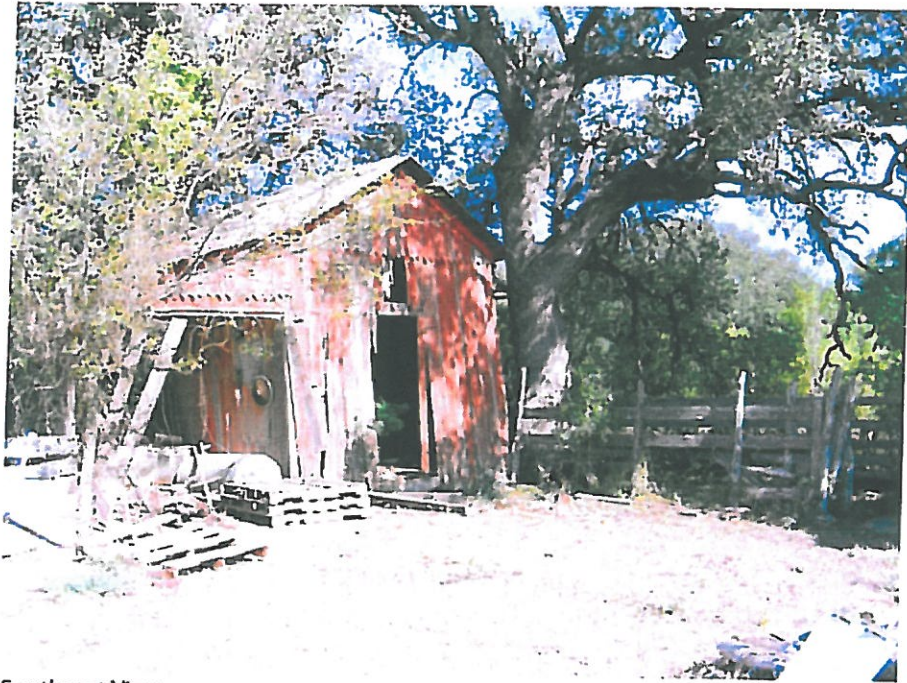
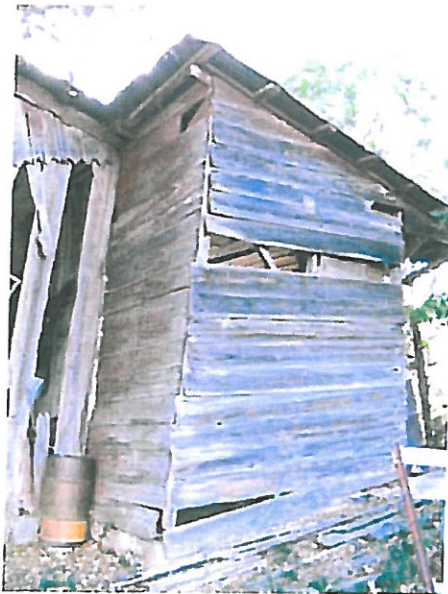
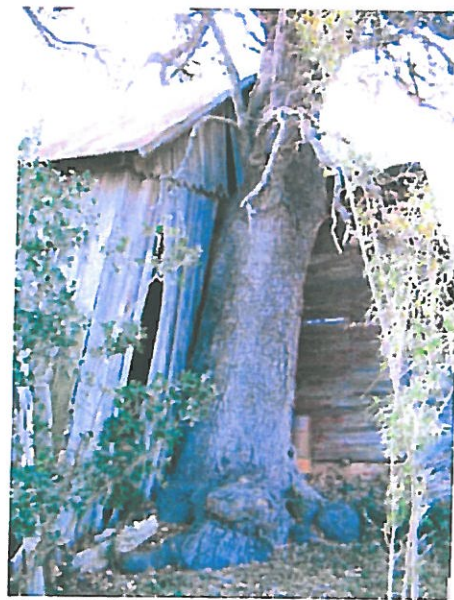
Foundation: The original foundation is composed of cedar posts set into the ground. The posts support the wooden floor framing. The entire wooden structure is deteriorated to the point that repair is virtually impossible.

Walls: The board and batten construction on east and south walls consist of vertical wood boards. The boards are 9 ½" by ¾" and the battens of 2 ½" by ½" located between two boards. These east and west walls are ornamented with zig-zag running horizontally from the lower parts of the roof. The entire building is painted in typical barn red. North and west walls have vertical 9 ½" by ¾" boards, but have no battens or ornament. The shed enclosure has the same board size but running horizontally on the west and south sides.

Roof: The roof consists of a single layer of corrugated sheet metal which appears to be in fair condition. This shed roof does not have insulation.

Windows: There are only two windows in the building. They are currently covered with plywood and seem to be in bad condition. The windows contain no glass and may more accurately be described as barn shutters.

Doors: The only existing door is in the middle of south wall and could be salvaged and repair.

A door may have been added on the east end of the barn, but it and its frame are missing. The resulting hole in the wall may just be the result of missing siding, not a doorway.

Comments: There is extreme termite damage to foundation, floors, roof framing, windows and doors. The foundation has failed and the growth of two oak trees has caused structural uplift on the floor and sideways thrusting on the walls.

Floors: This barn has a wood floor over wood framing; the floor as well as the structure is in critical condition.

Comments: This building needs to be reconstructed in order to preserve the essence of the farm complex.

The framed barn is in such critical condition that the only viable treatment will be reconstruction if the structure is to continue to relate its historical importance to the site. A few building components can be salvaged.

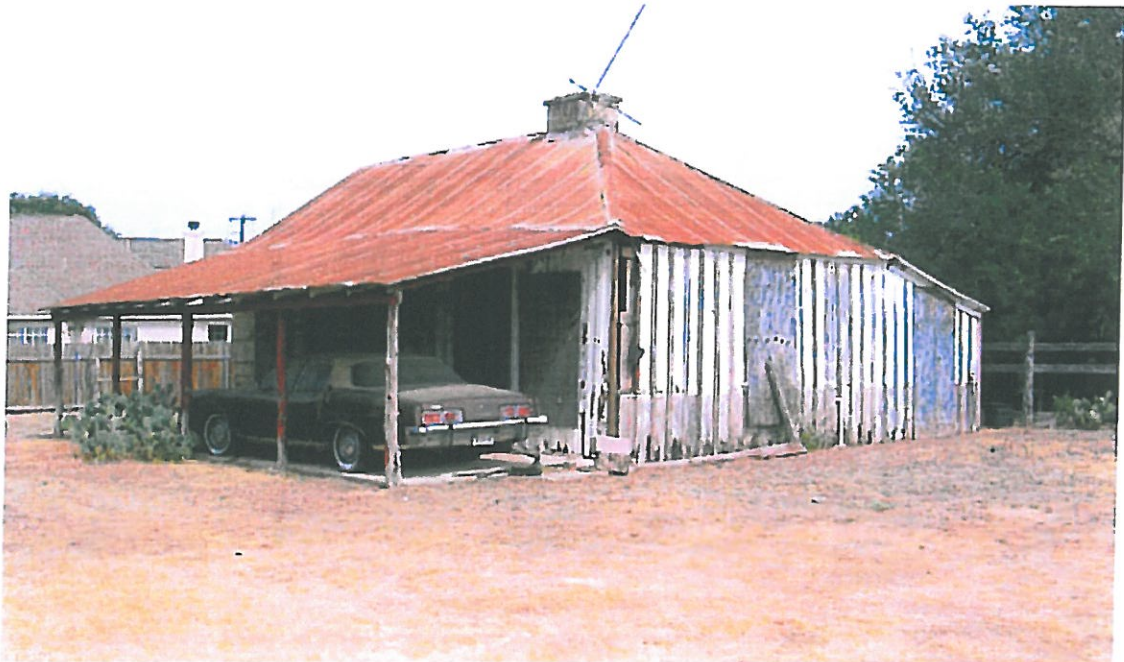
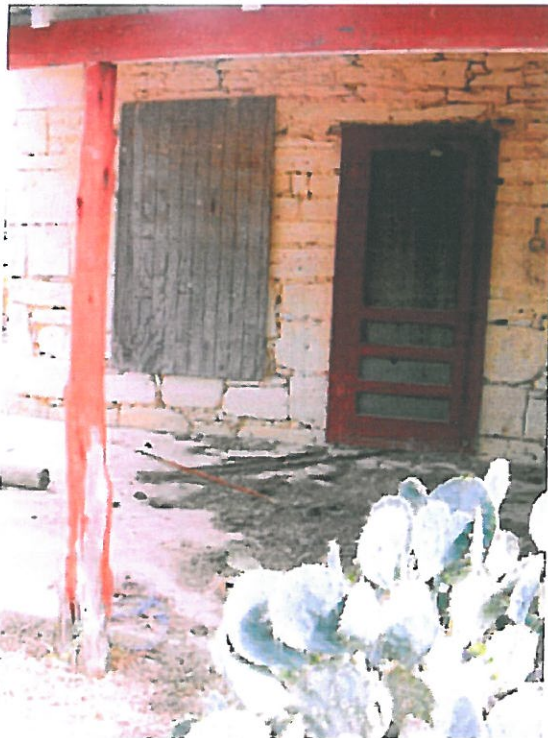
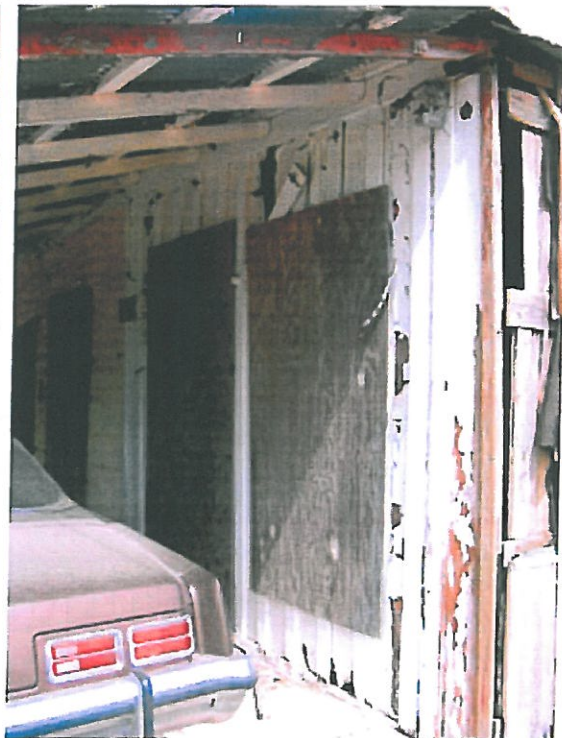
Assessment Rating: 5-Excellent 4-Good 3-Fair **2-Deteriorated** 1-Crisis

Foundation: The foundation for masonry houses of this period in Texas were no more than the masonry wall built within a trench a few feet below the existing grade. The foundation has supported the masonry walls well, and cracking is insignificant. The interior floor is probably supported by wooden joists and beams supported by the masonry walls and a few posts within the center of the rooms. The foundation for the framed additions appears to be cedar post. Since the floor level is so close to grade, and no ventilation openings are apparent around

the base of the structure, the floor structure throughout is probably severely rotted.

Walls: The masonry walls are in very stable condition. Almost all of the limestone is in good condition (except on the bottom of the west and north walls where water damaged has occurred.) The structure added to the east of the building is of board and batten construction. The walls of this addition are finished with white paint and reveal substantial deterioration due to water and termite damage.

Roof: The corrugated sheet metal roof is rusted but in serviceable condition.

Windows: Six over six double hung wood sash and wood frame. Windows have been vandalized, missing mullions and glass.

Doors: One four panel wood door survives and is thought to be original to the 19th century construction. Front door has been replaced with a 20th century six panel door.

Comments: A 4" concrete slab has been poured under the front (south side) porch. The porch is supported by cedar posts with 2" by 4" roof rafters. This porch structure is in good condition and will need minor repair work. The ground level around the house is very close to floor level. There is no room for sub-floor ventilation therefore extreme grading is required around this building to assure that water does not damage the structure.

The masonry and board and batten residence requires extensive rehabilitation. The structure is not only significant because of its age, but the methods of construction employed over the course of its life. These methods of construction speak to the historical conditions present as the house was built, including: 1) economic conditions experienced by the builders, 2) readily available materials and 3) available craftsmen. For these reasons, all of the structure has significance and should be considered for preservation. Unfortunately, most all of the wooden elements of the house have been severely damaged by termites. If all of the building is to be preserved, then the masonry elements will be repair but the wooden parts of the house will have to be replaced.

- conditioned. Replace rotted ceiling members.
- 4. Clean and re-point sandstone walls on the exterior. Replace plaster and paint interior walls.
- 5. Replace rotted wood on interior and exterior walls and roof members and paint them.

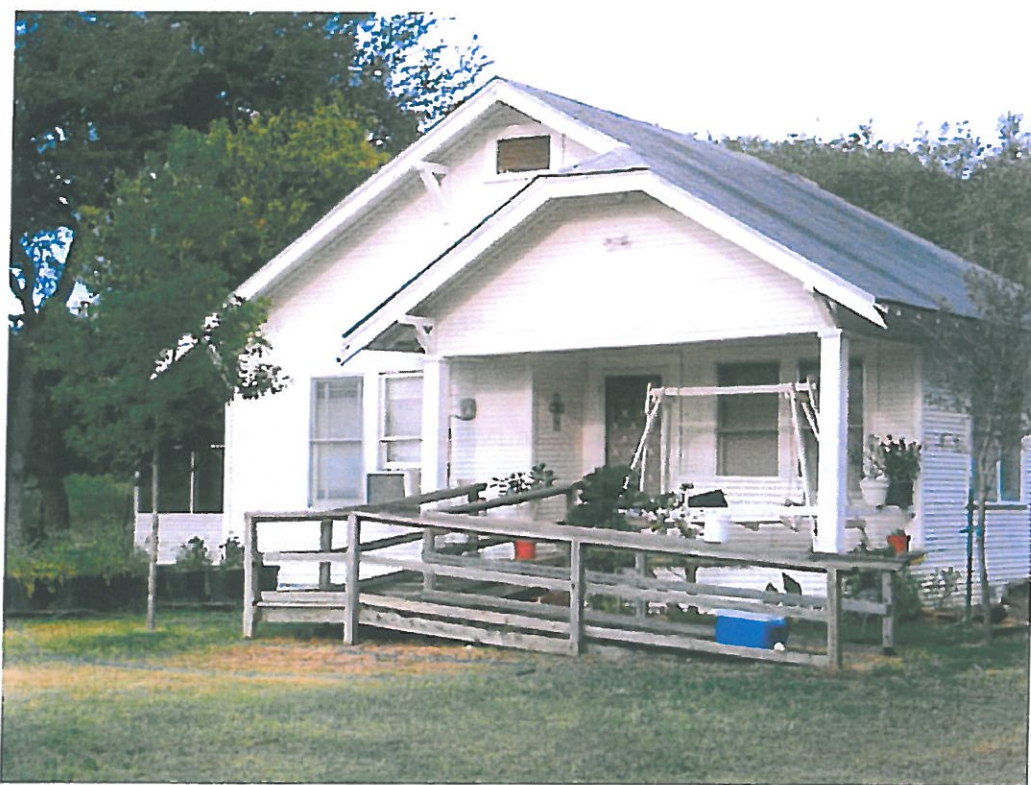
Voelcker Framed Residence

Foundation: The foundation should be reviewed by an engineer to determine the extent of settling and the best procedure to stabilize it and so preserve the house.

Walls: The wood horizontal 2 ½" siding is original, and it is painted white. The paint on the north and west sides is deteriorated. There are some parts of the siding at the bottom of the walls that have been damaged by water and moisture.

Roof: Some roof members are rotted and hollow. This is visible from outside the north-west side of the house.

Windows: Frames, trim and sills are made of wood. All windows seem to be in good condition. Some trim and sills are damaged by water, weather and time.

Doors: All doors are wood, with wood jambs and thresholds. Some jambs are visibly deteriorated, particularly in the lower parts. Most doors are in reusable condition.

Comments: The main concern is the state of the foundation. Plants in close proximity to the structure are threatening its preservation.

The framed residence, which has been occupied continuously since it was constructed is in good general condition and is an excellent candidate for restoration or rehabilitation. The most significant period of the houses's history should be determine and used as the period of its restoration. Occupied buildings remain in better condition than those that are vacated. As a short term treatment approach the building should continue to be used by a caretaker as a residence, preserving it until the new use is determine and the building can be restored.

- 1. Grade around of building to achieve proper drainage.
- 2. Determine which wood members are rotted and replace them.
- 4. Determine which air conditioning system should be installed.
- 5. Determine if there is structural damage due to foundation settling and rotted floor members. Make repairs as needed to preserve the building.
- 6. Replace and/or repair doors and windows parts where needed.
- 7. Repair and refinish deteriorated wall elements.
- 8. Repair roof.
- 9. Re-paint entire building.

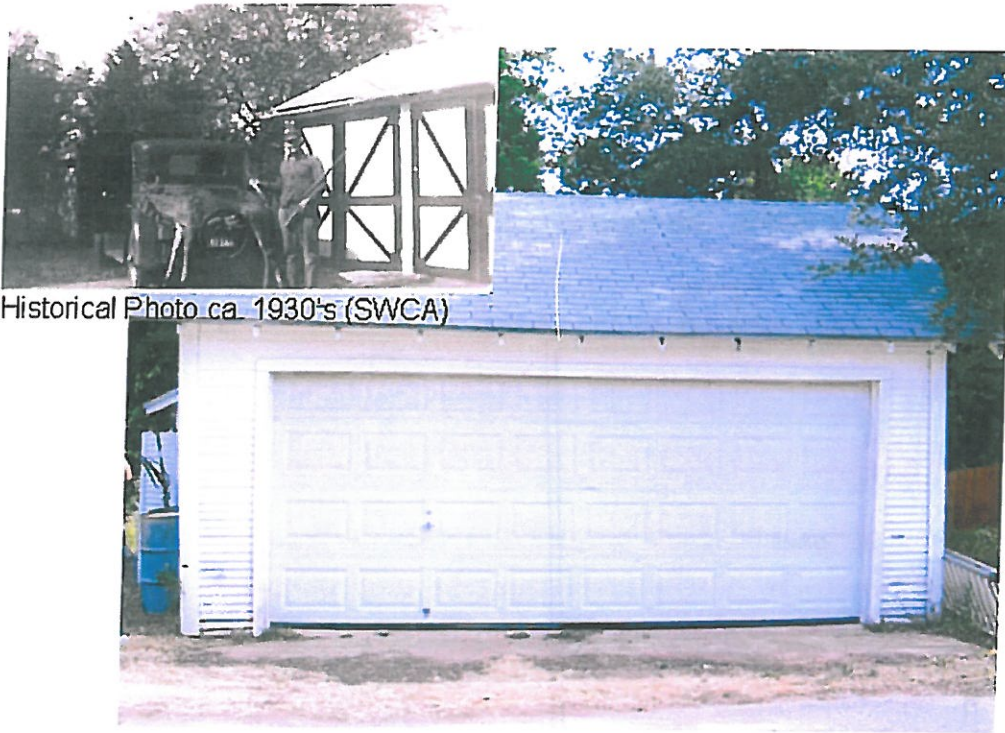
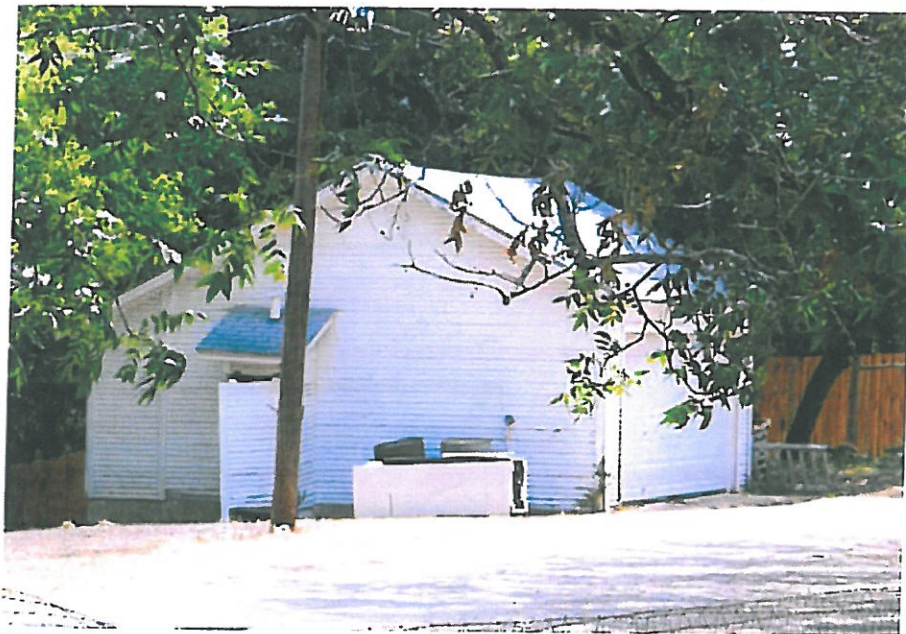
Assessment Rating: 5-Excellent 4-Good **3-Fair** 2-Deteriorated 1-Crisis

Foundation: Masonry and concrete foundation appears to be in good condition. However, a significant crack is visible in the north-west side of.

Walls: Wood siding finished with white paint, original to the structure, mostly in good and reusable condition; however there are some broken and rotted members. There is no foundation curb around this structure and the bottom of the siding shows signs of deterioration. There are no water or moisture barriers around this structure.

Roof: Asphalt shingles in good condition, just a couple are broken. Some sagging of the roof is visible at the middle of the structure.

Doors: The original garage had two doors, they were replaced by one large one, and it is in good condition. The trim is a little deteriorated at the bottom, but in general is in condition.

Comments: This structure is part of the complex and could easily be repaired and reused. Reinterpreted as the Voelcker's had it, with the two garage doors, more farm looking, with the white painted wood siding and red barn trim paint.

While the framed garage is not significant in its own right, as a part of the historic farmstead it should be considered a contributing structure worthy of preservation. Its generally good condition should allow it to be used for a new auxiliary use, supporting the selected uses of the farmstead complex, or the park. To allow for the complex to be preserved as a whole, this structure should be also restored as it looked during the most significant historic period of the site.

- 1. Grade around garage for proper drainage.
- 2. Determine which wood members are broken and/or rotted and replace them.
- 3. Determine if an air conditioning system should be installed to better preserve the structure or to facilitate a new use.
- 4. Determine if there is structural damage to the foundation or roof members. If so, make the repairs needed to preserve the building.
- 5. Replace doors to match like original design.
- 6. Repair and refinish damaged walls.
- 7. Repair roof as needed.
- 8. Re-paint entire building.
